September 16, 2024

St. Anthony School Building Assessment - Volume I

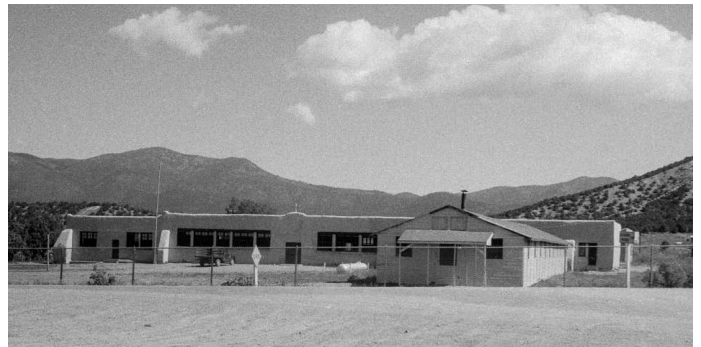
Street & number: 15086 75 State Highway
City or town: Peñasco
State: New Mexico
County: Taos
Zip Code: 87553

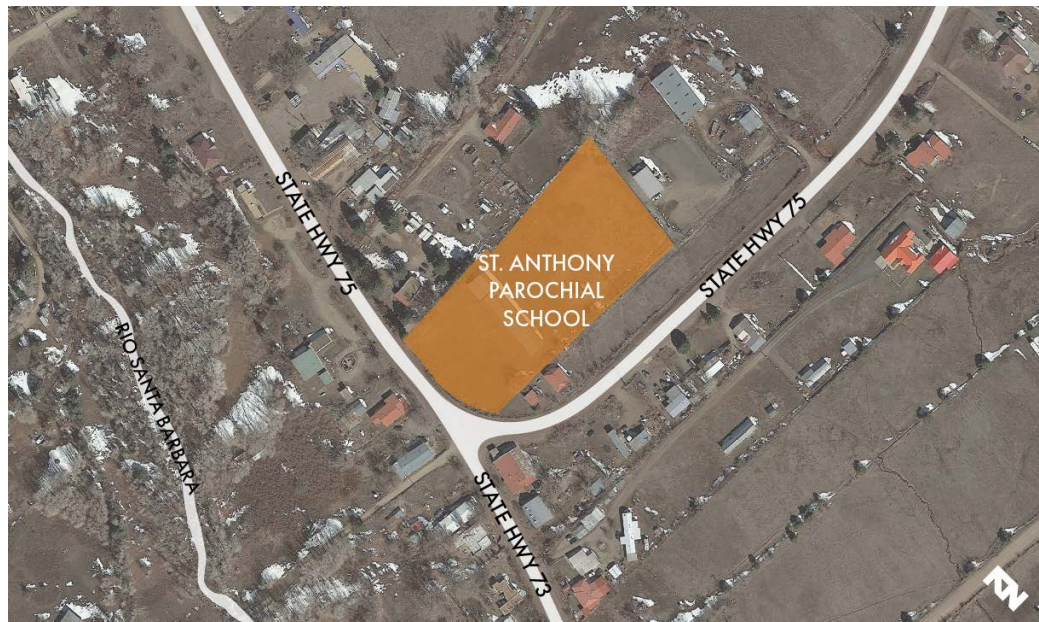
The site was originally left untouched after the demolition of the Hot Lunch building and an old shed on the East side of the building, remnants of its demolition, still on site. During the 1997 assessment, repair work was underway to remove the cementitious plaster.

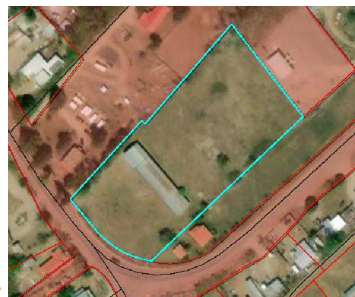
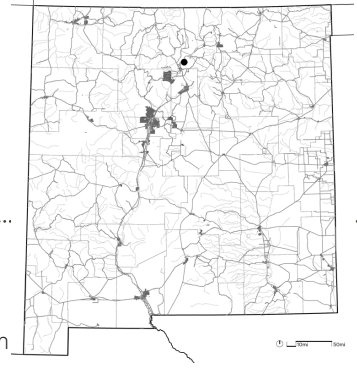
Historic Preservation Standards

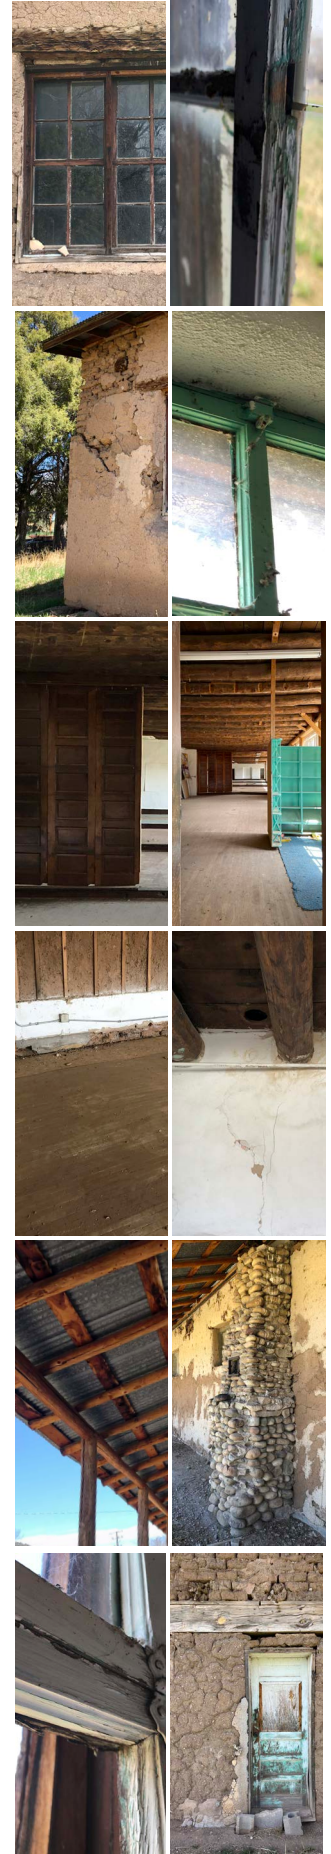
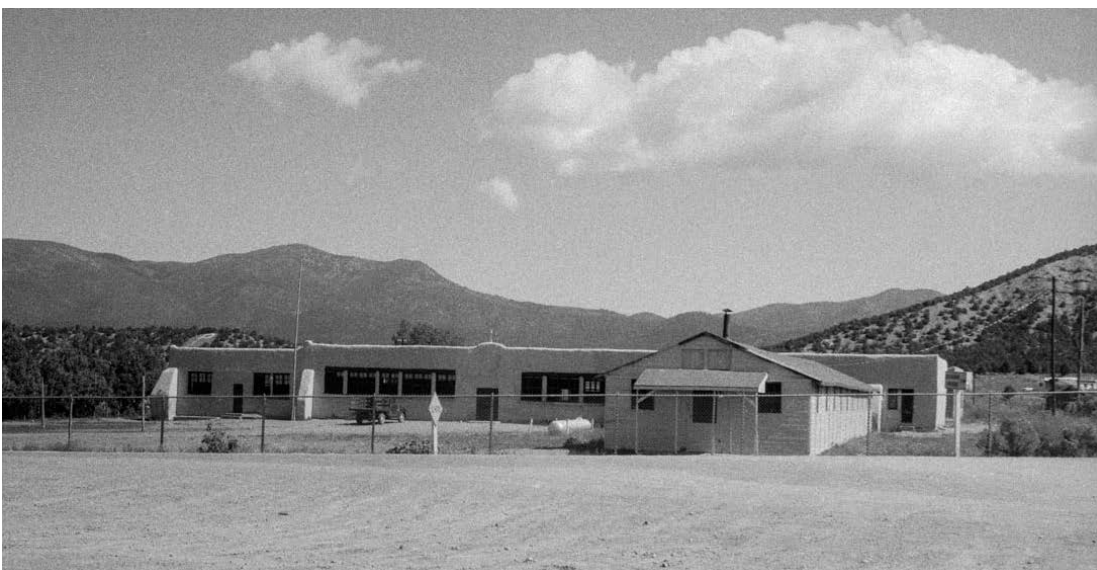
02.b. Existing Building Condition

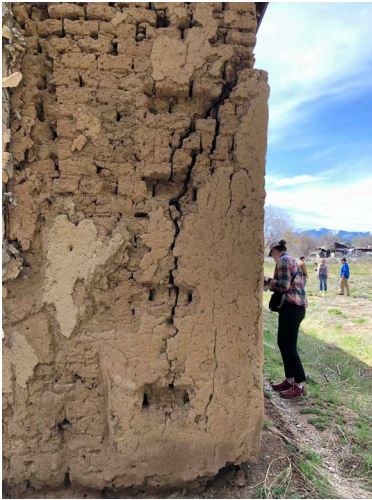
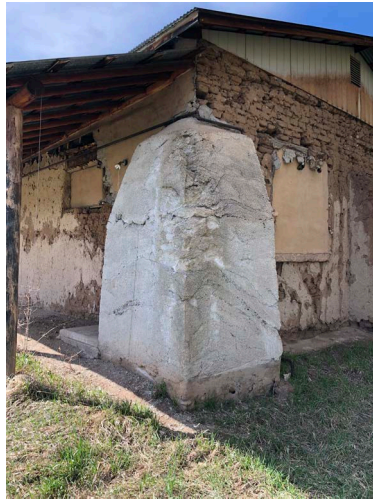
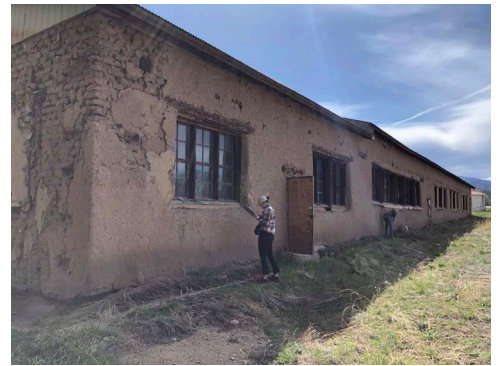
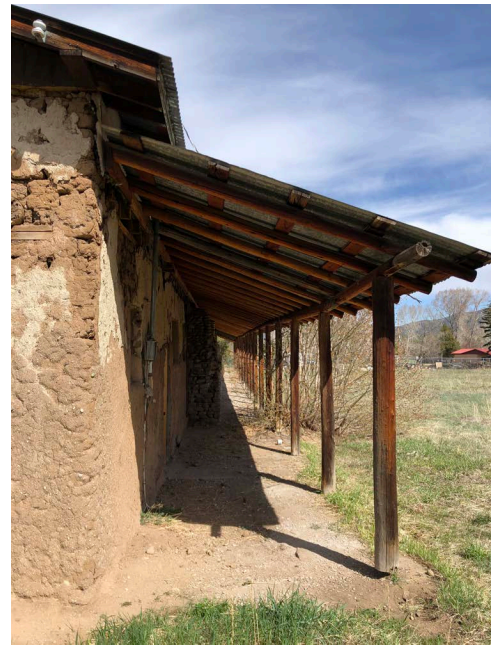
There is basal (rising damp) erosion along the west, south and east elevations, the north elevation is protected by a portal. The erosion has been most detrimental below the windows where the use of concrete sills have not provided a sufficient drip edge to carry water away from the adobe wall below.

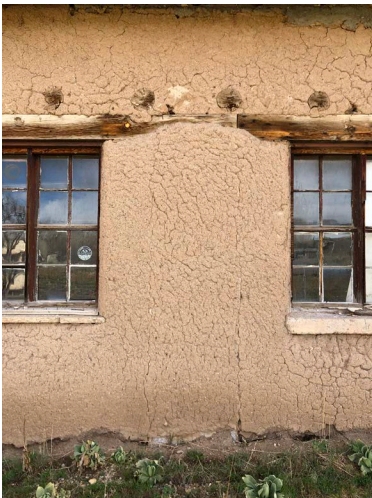
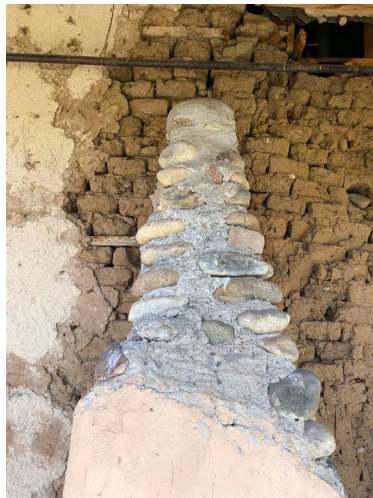
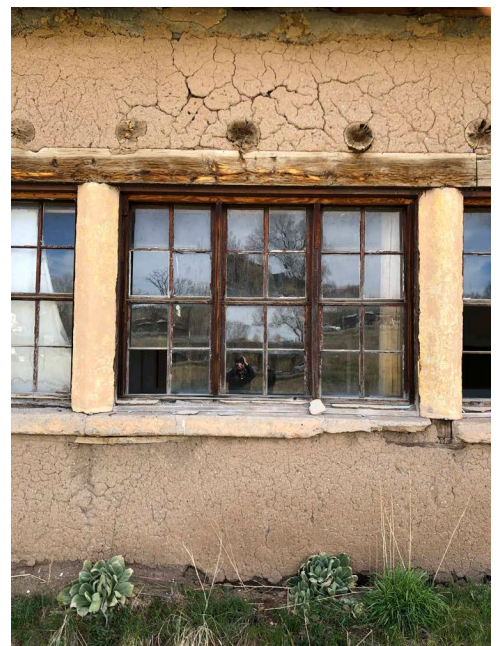
02.b. Existing Conditions - continued

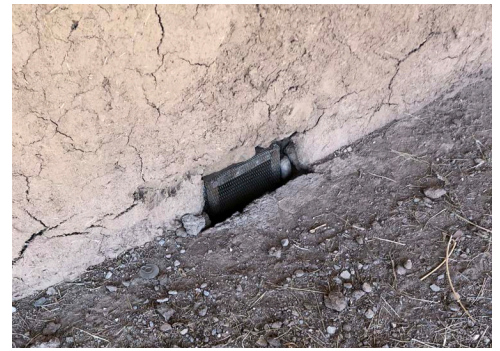
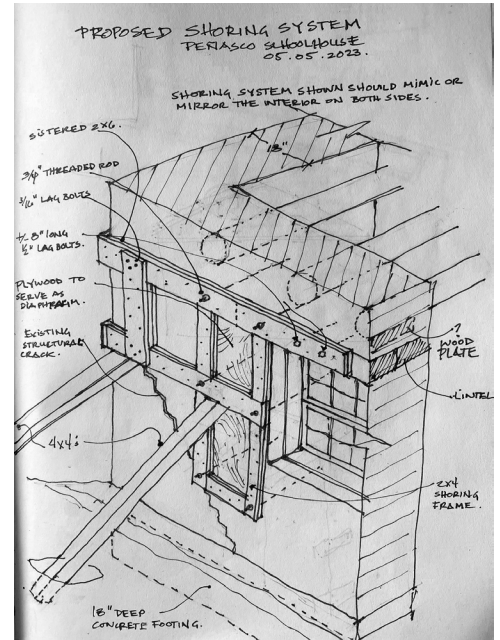
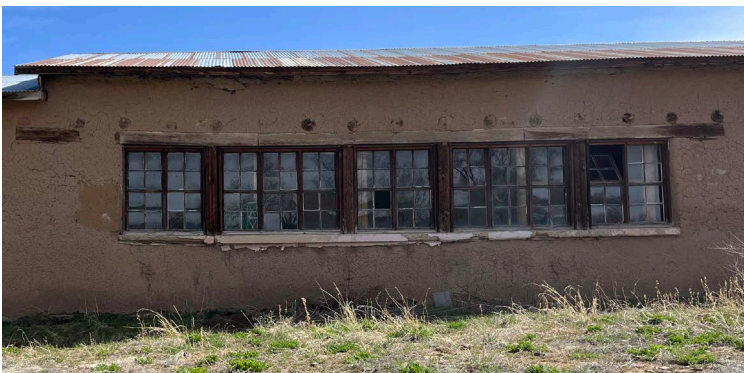
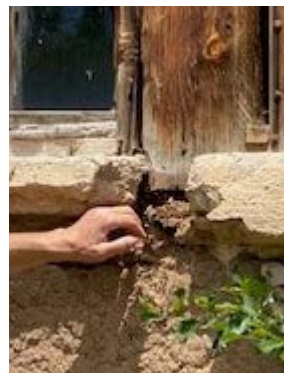
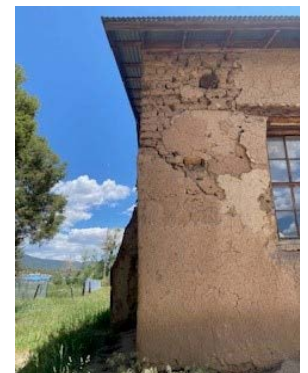
ISSUE/STUDY NEEDED: The wood lintel and sill at the longest span window shows signs of deterioration or sagging due to lack of structural support. The columns between window bays do not have a stable base support. The wood members are weathered and deteriorating. There may be some settling beneath the window caused by ground water rising damp as the grade and vegetation has accumulated at the base of the wall beneath the window. Site grading work will be needed before a further structural assessment can be done to study this area. It is possible that the adobe underneath the window may have to be removed and replaced in order to correct this issue.

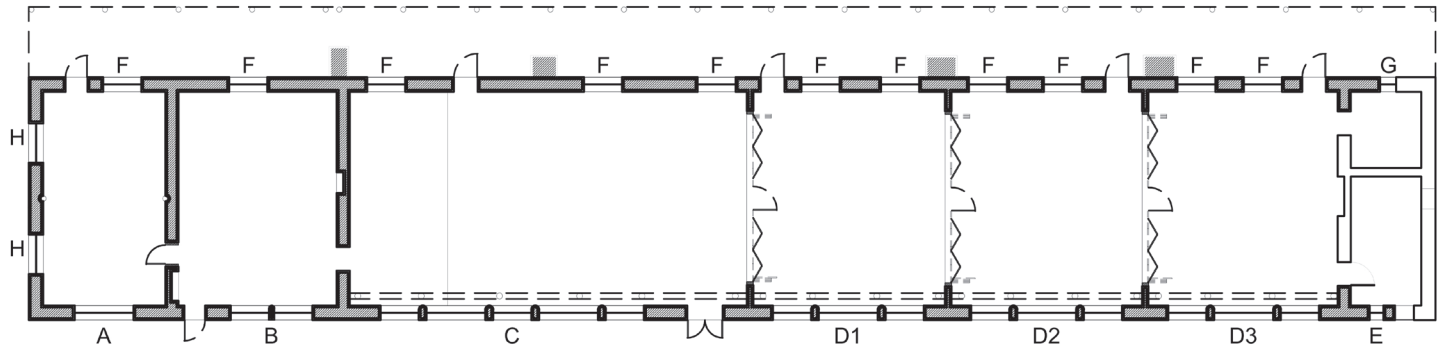
FLOOR PLAN with WINDOW TYPES LABELED "A" THROUGH "H"

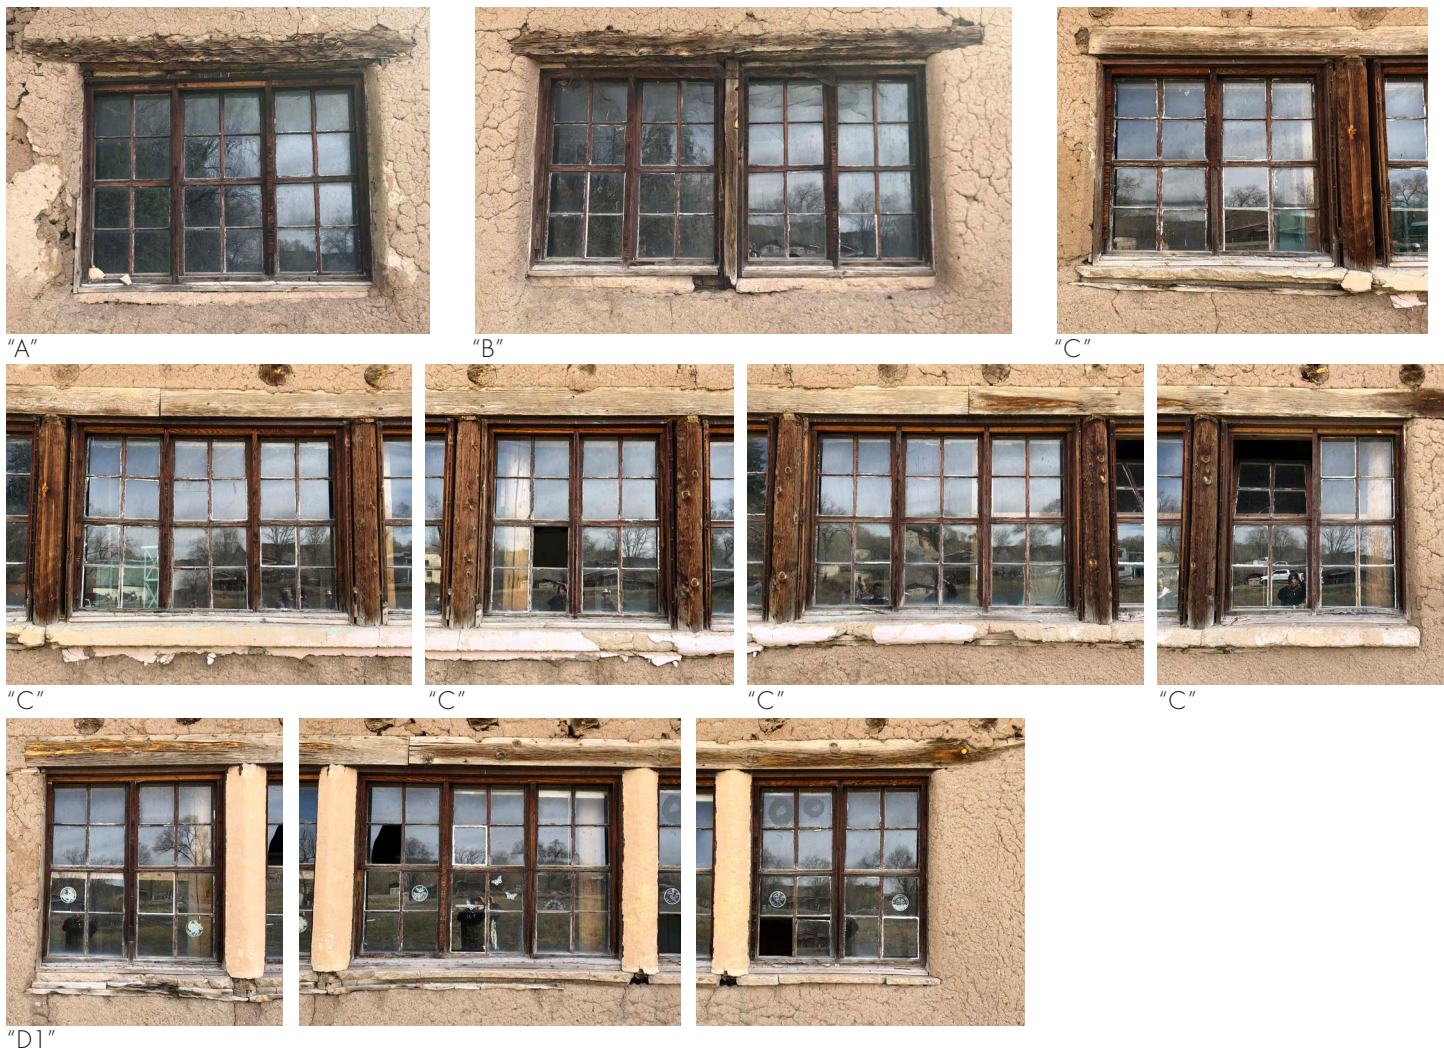
Each window has been photographed and documented as part of the assessment. The repair work needed will be further defined during subsequent construction document phases.

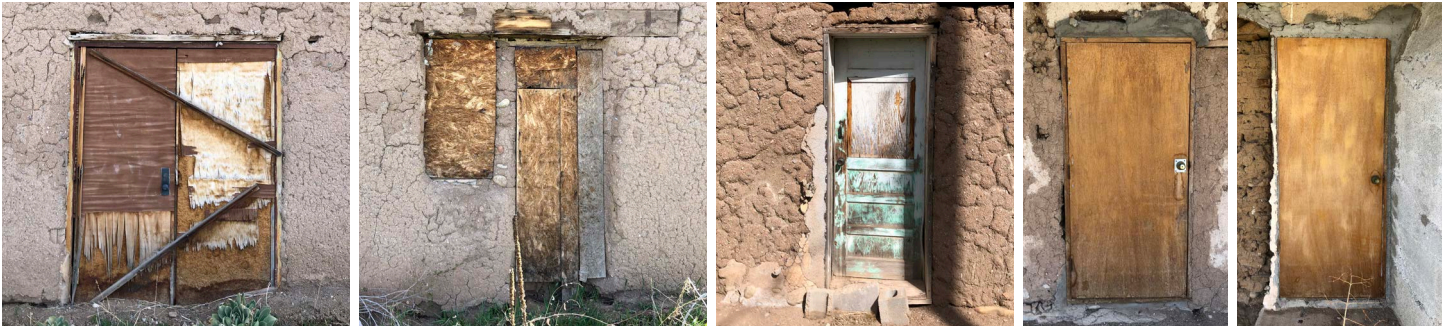
Historically, the classrooms had folding panels serving as room dividers with nine panels each with one operable door in the center. Currently, there is only one set of four panels on the north side between Rooms 3 and 4. (Double check with PVHPS, if the other panels and doors are being stored off-site somewhere)

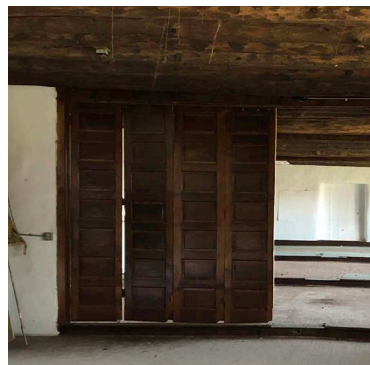
John Collier, Jr., "Penasco, New Mexico. High school supported by the state but administered by the Catholic church," 1943

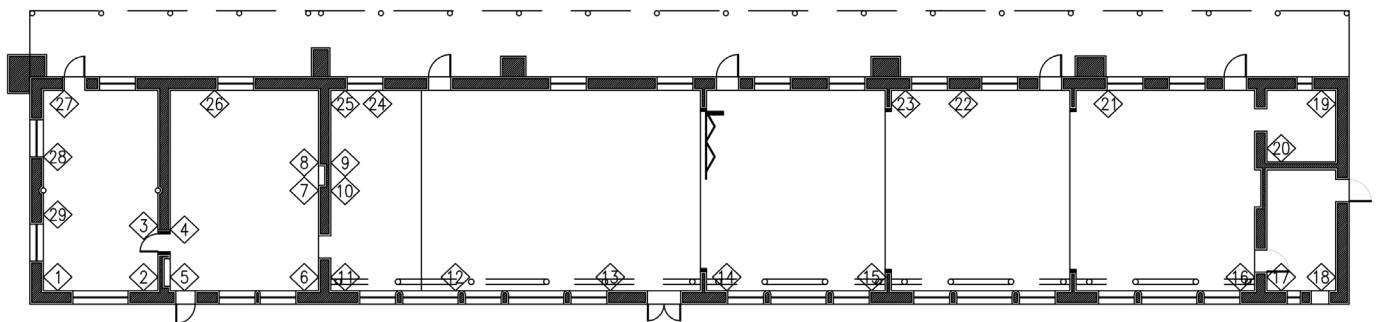
The interior walls are plastered over the adobe. There are several large cracks appearing in walls that also reflect the deterioration on the exterior. The floor plan below shows the number of cracks and their locations. The most sizable are shown in the photographs below.

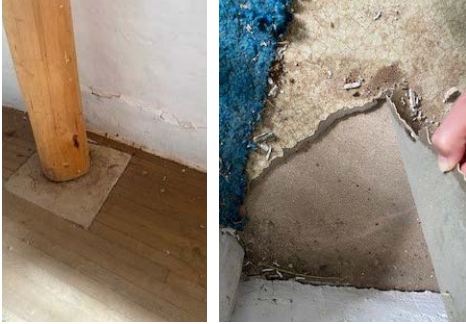
In Room 1, the floor is presumed to be pressed wood (but concrete was uncovered) with linoleum and carpet. The floor seems fairly level and in good condition. The linoleum and carpet should be removed.

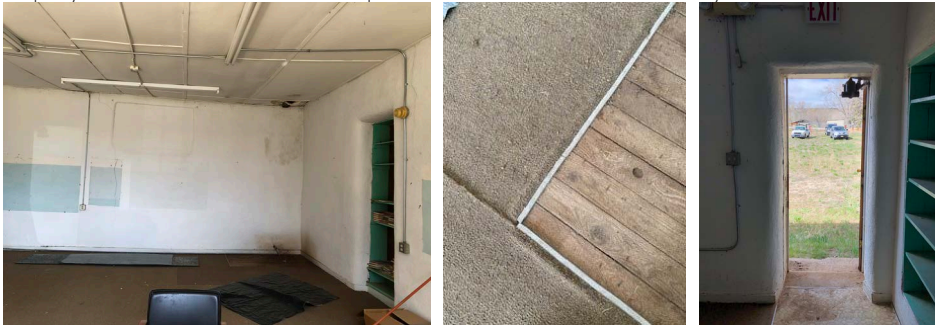
Room 3, the main room with stage, has 2 1/2 inch wide tongue-and-groove floor. This floor is unfinished, except for a small area of blue carpet on the south side of the stage. The wood flooring is in good condition. There appears to be a slight crown at the center of the room. This may be caused by the deterioration of the ends of the floor joists or by settling in the exterior walls. More study is recommended.

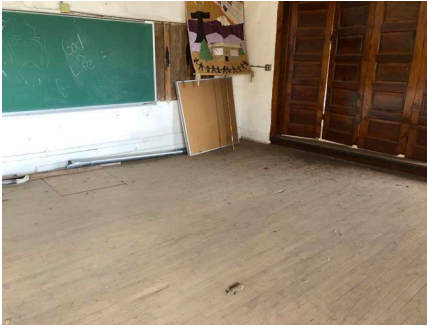
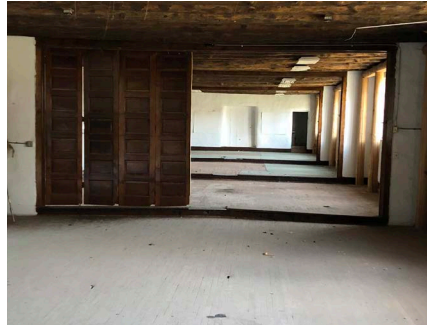
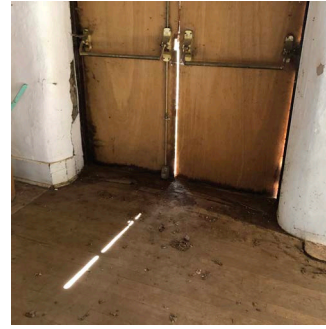
Room 4 has 2 inch wide wood flooring. The floor is in good condition. This room is also showing signs of crowning. The north side of the floor has had some selective demolition done to examine the end condition of the floor joists. See sketch by Francisco Uviña for proposed repair work.

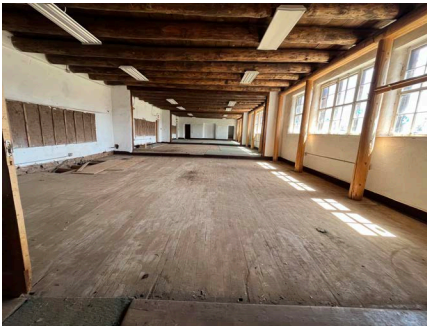
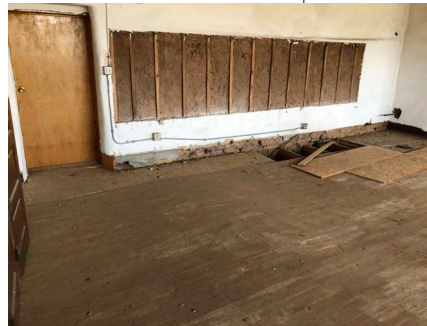
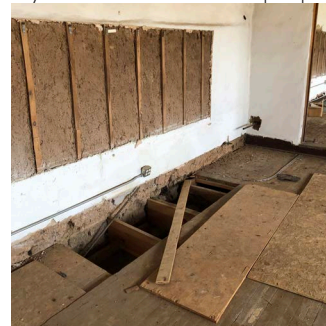
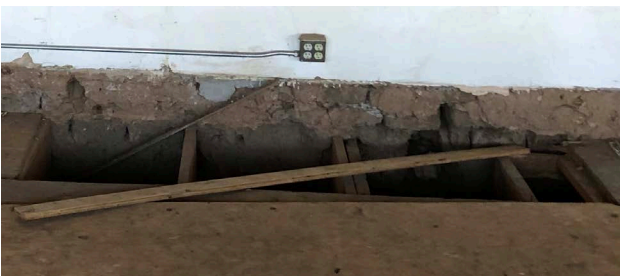
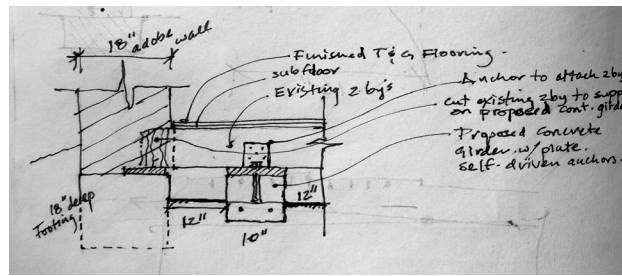
Room 5 and 6 have 2 inch wide wood flooring. The floor is in good condition. Room 5 is also showing signs of crowning. Rooms 5 and 6 have remnants of carpet padding. Rooms 3, 4, 5, and 6 all step up an average of 6" from west to east. All rooms have doors exiting north to the portal which slopes with the grade. Internal ramps will need to be designed for ADA accessibility. As noted earlier, Rooms 3, 4, 5, and 6 all have 18 inch squares cut through the flooring to provide a footing for the shoring supports along the south side of the building.

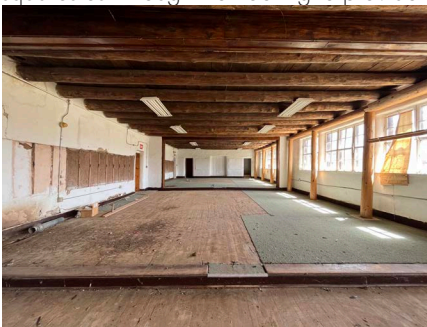
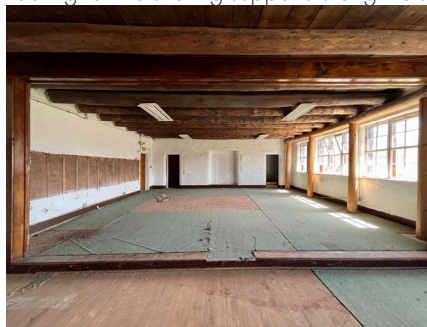
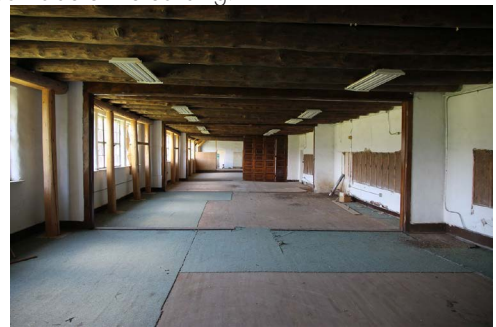
The two eastern rooms are restrooms opening onto Room 6. The northernmost room has an old linoleum floor which is in poor condition. The south restroom has a built-up floor with a wood subfloor covered with concrete.

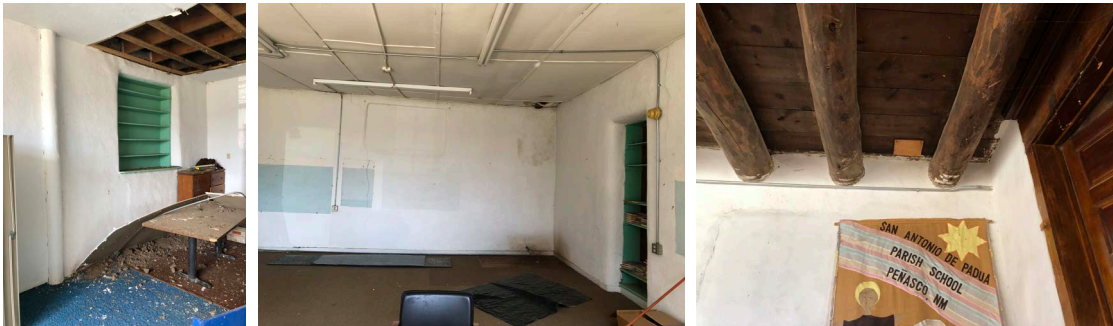
Room 1 has a sheet rock and plaster ceiling. There are some portions of the ceiling that has been removed either from a roof leak or selective demolition to review the structure above. Room 2 has what appears to be a plywood ceiling in a board and batten layout based on the plywood sheet size. This ceiling is in good condition. Rooms 3 through 6 and the easternmost rooms have exposed vigas with +/- 8 inch wood planks above. These ceilings are in good condition.

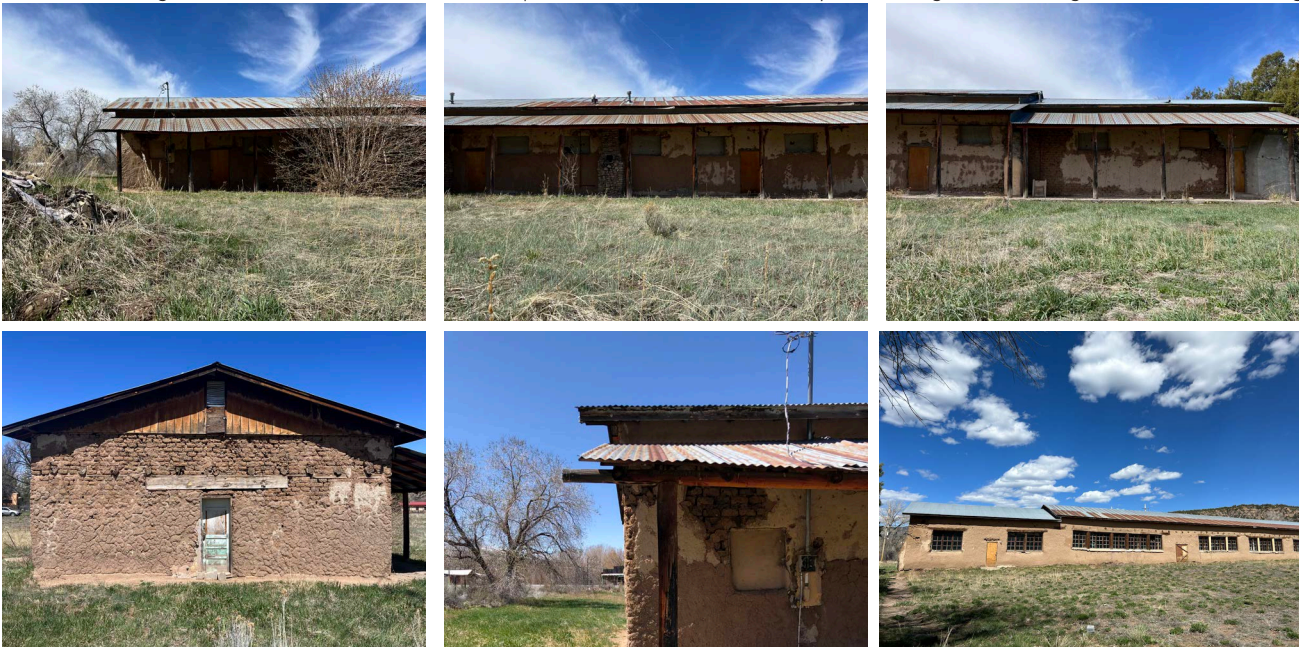
The portal shed roof was added at a later date (unknown).

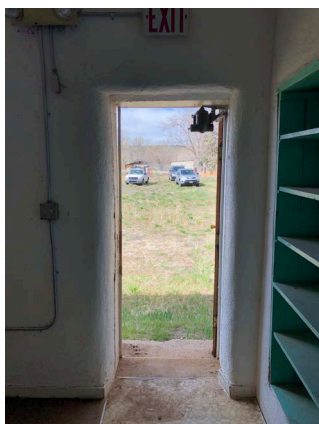
The DOORS are set near flush with the exterior of the building, so that when exiting from the interior, the width/depth of the wall inhibits the clear approach for accessibility. None of the doors are original to the historic building. Door placement within the wall and door frame will need to be studied in design.

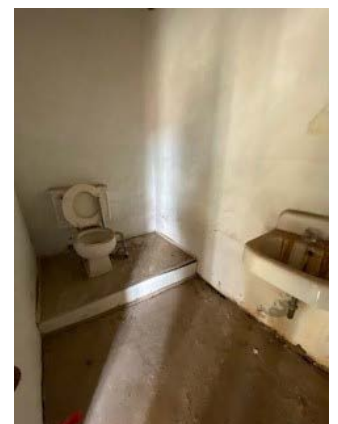
03.f Permitting and Approvals Process

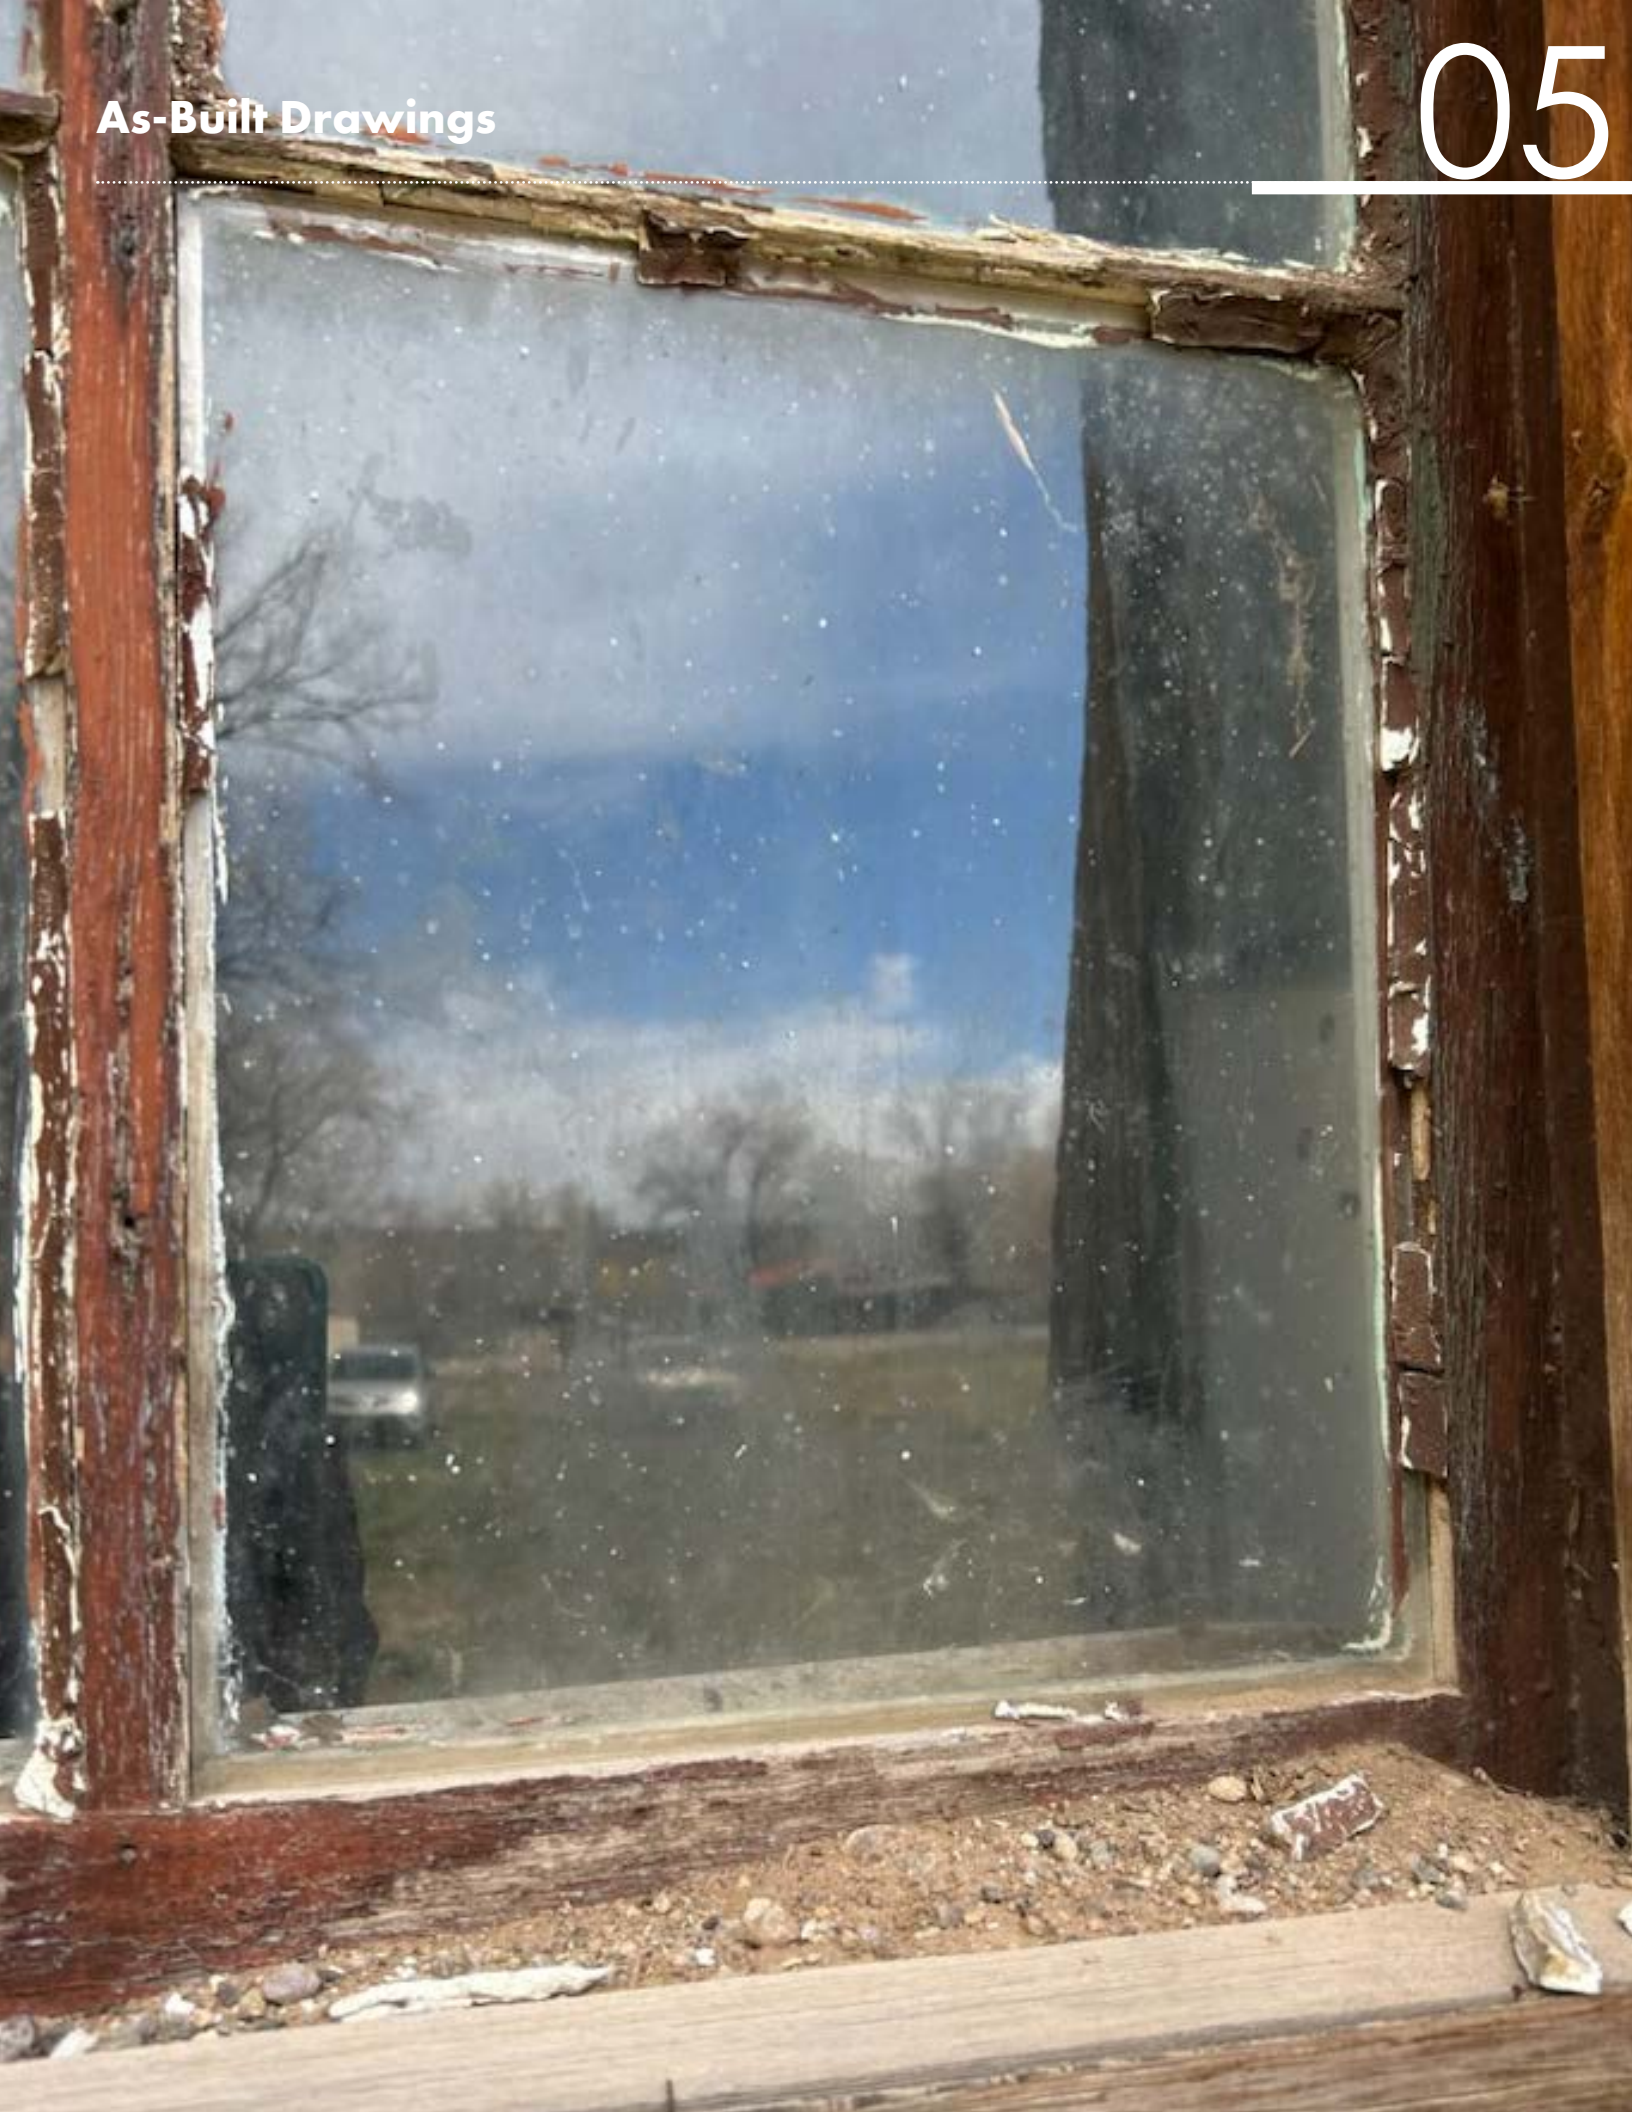
PVHPS - ST. ANTHONY PAROCHIAL SCHOOL

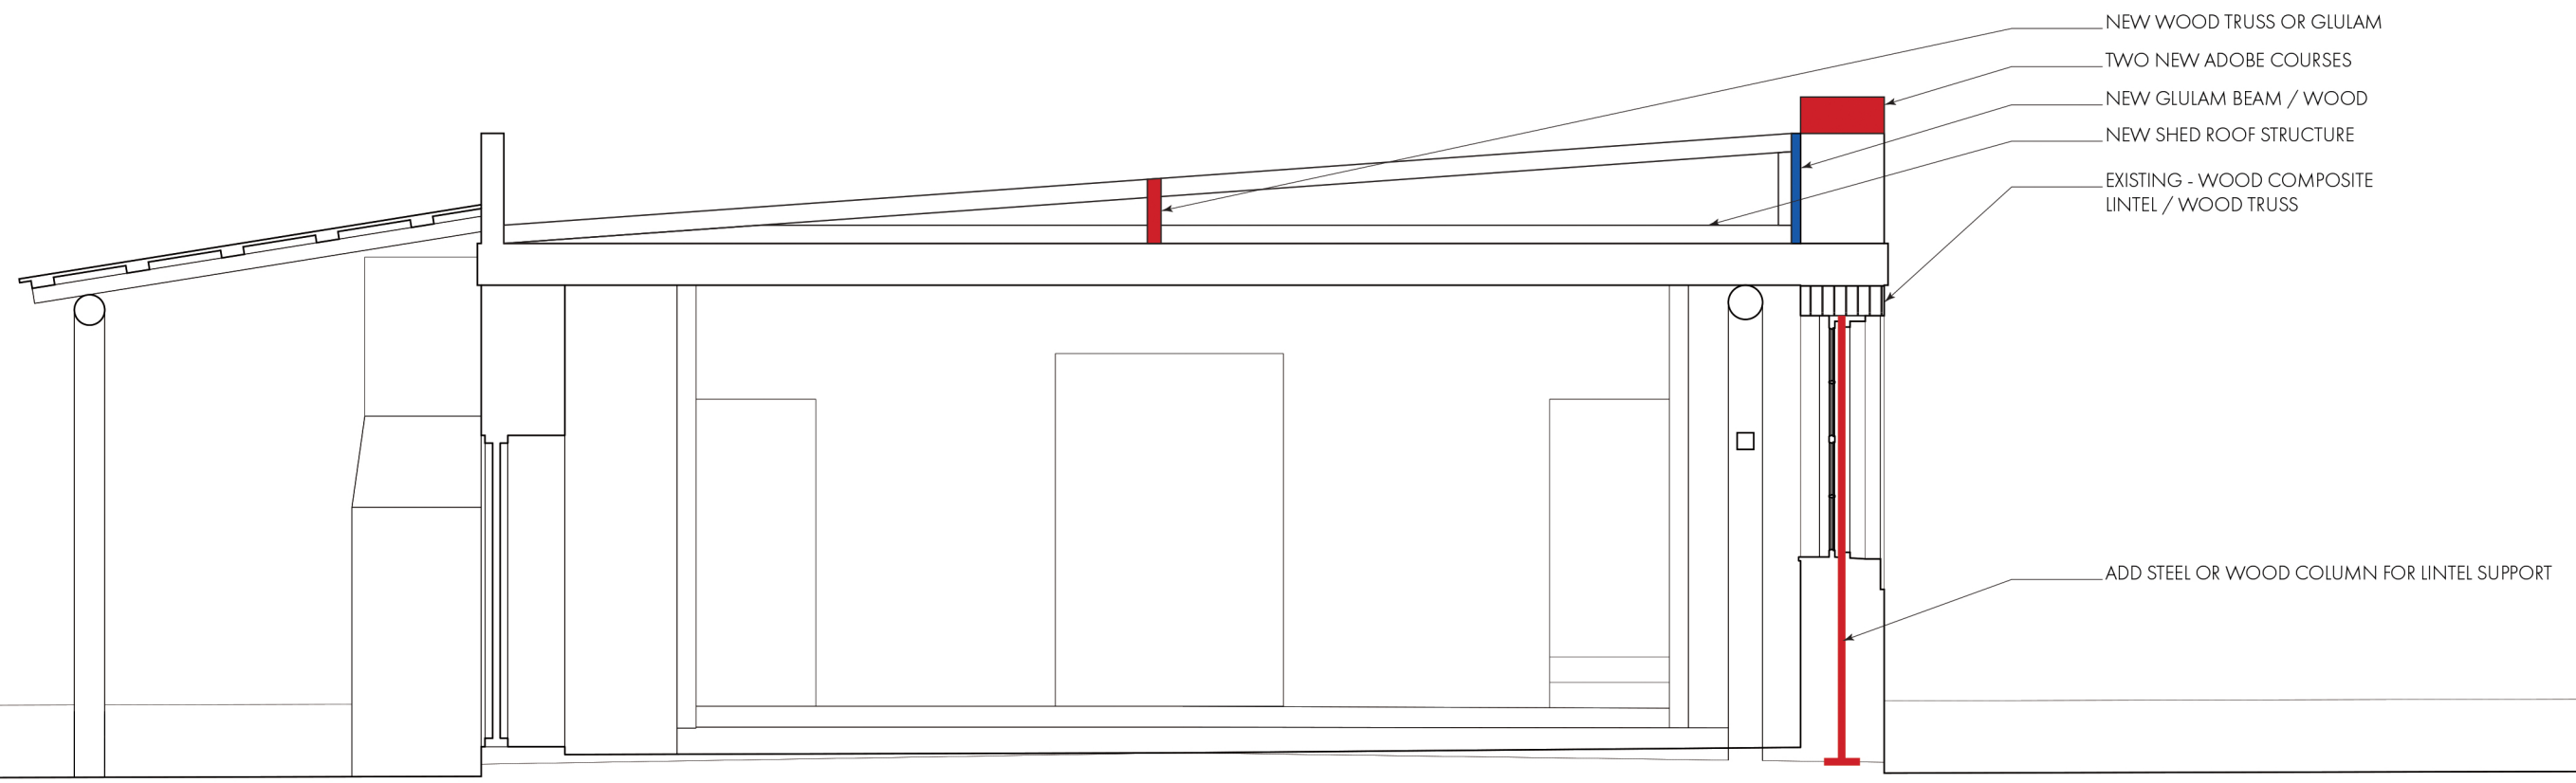
NEW PROPOSED CONDITIONS

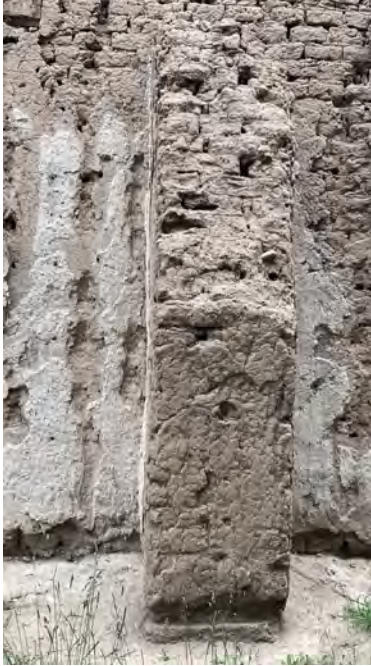
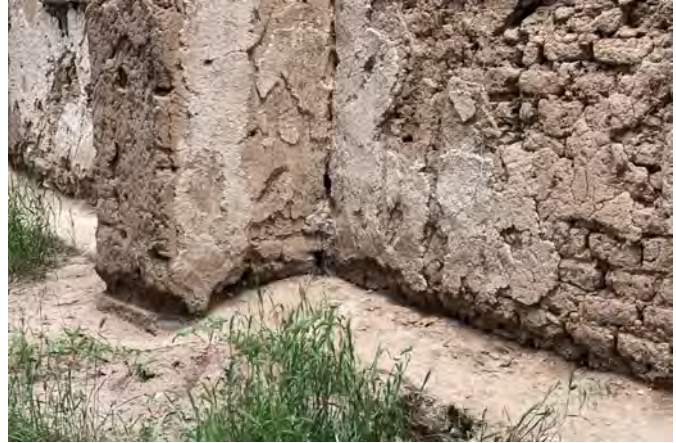
Examples of deterioration at the base of adobe walls due to moisture infiltration caused by grading and drainage problems.

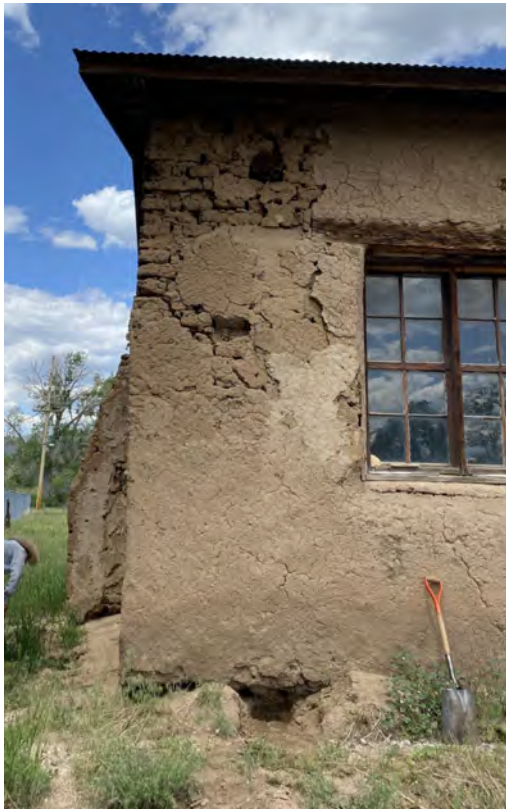
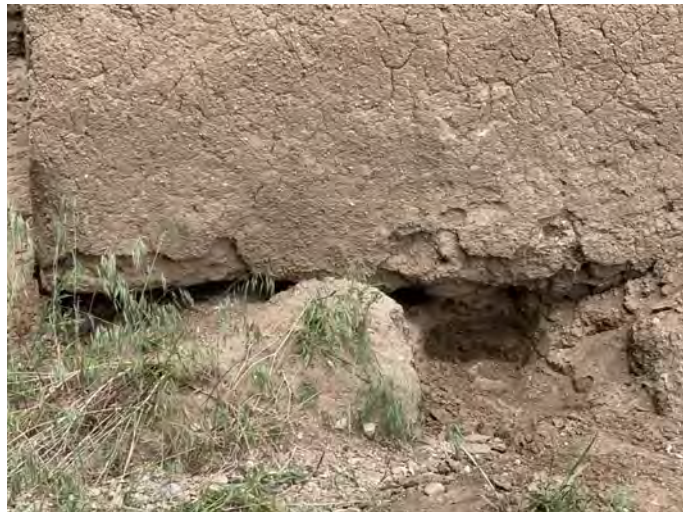
DRUC ENGINEERING, LLC
STRUCTURAL ENGINEERS

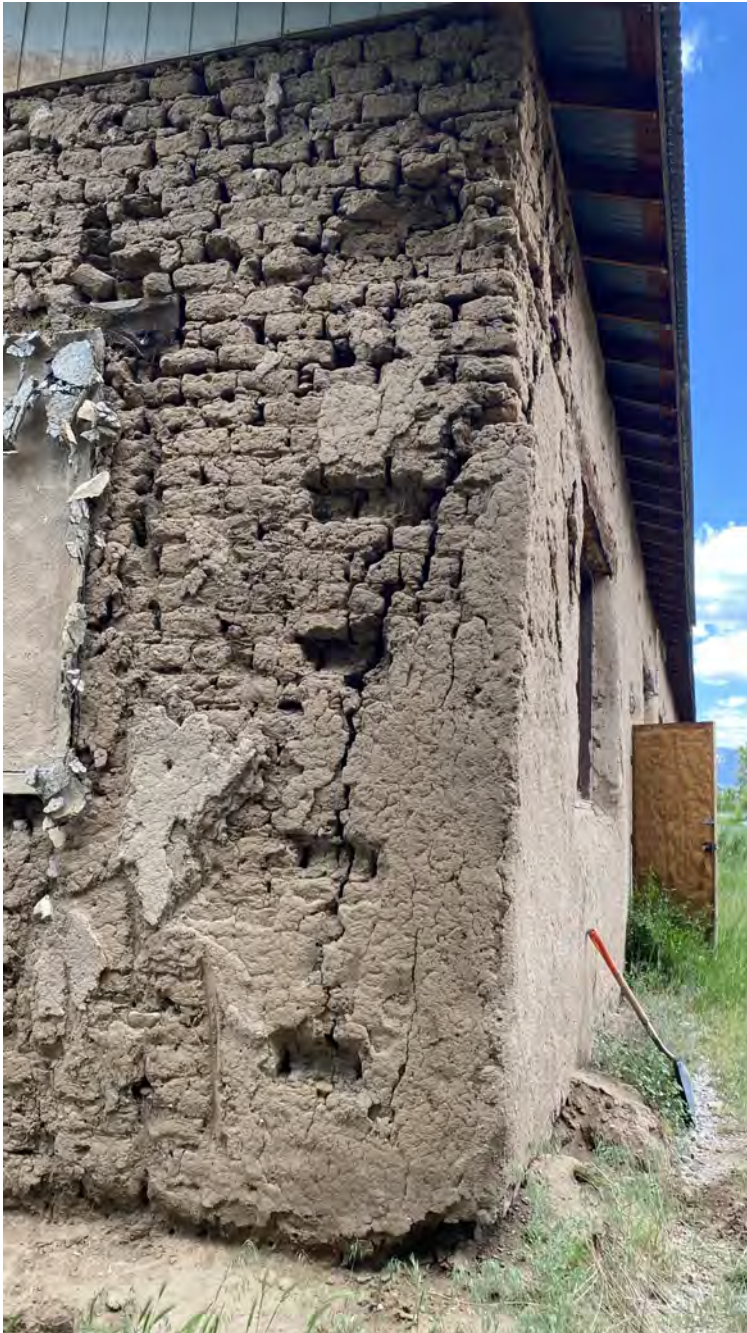
The adobe corner is separating away from the wall. Base of the wall is undermined. Rebuilding the corner and stitching into the remaining adobe blocks is necessary.

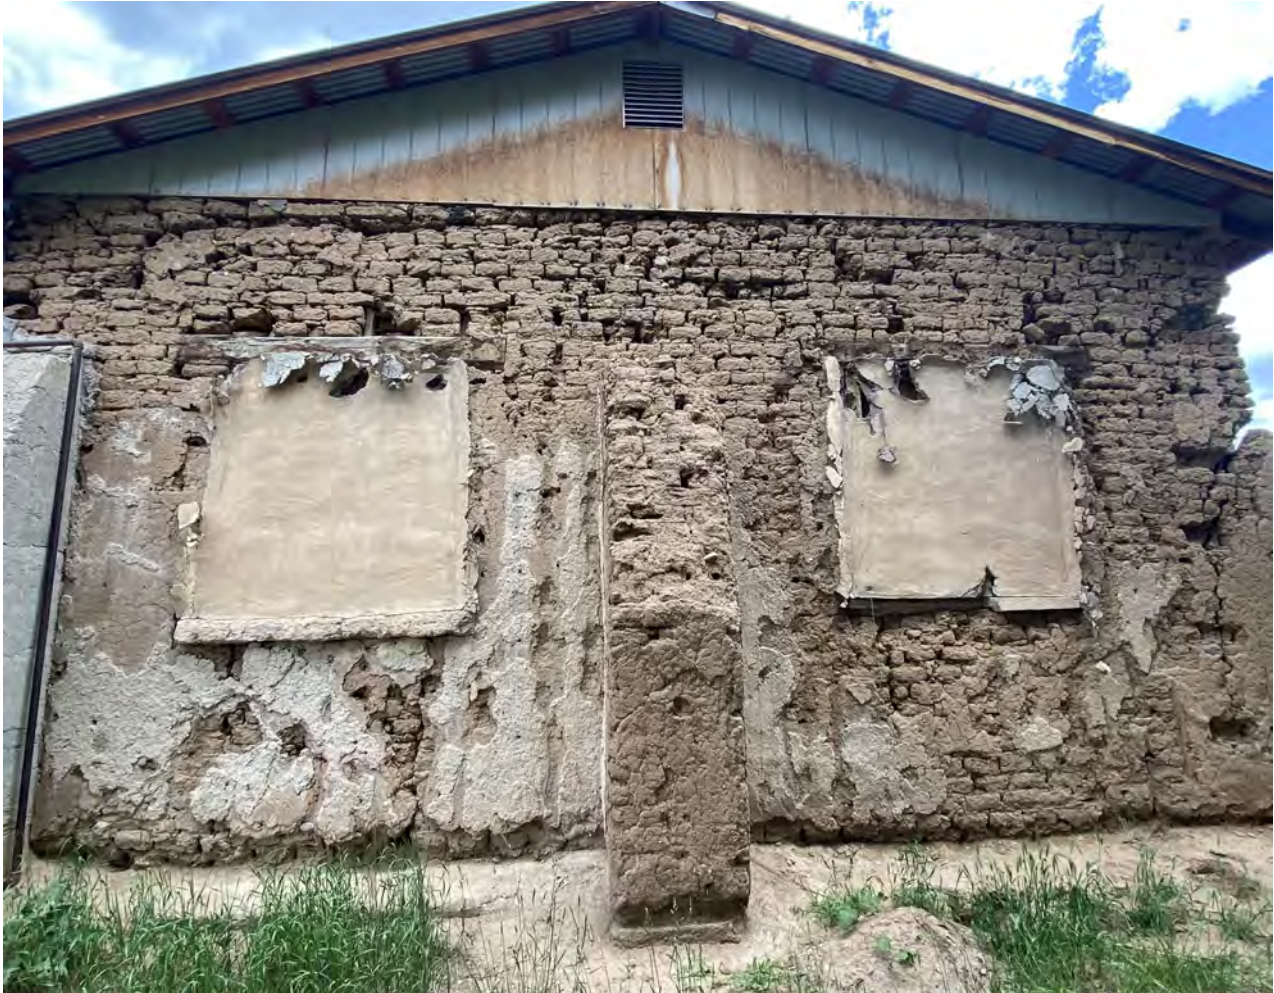
Northwest (side) wall.
Cracks in the wall
Base adobes are deteriorating
Adobe blocks are missing and decomposing.
Buttresses were added.
