September 16, 2024

St. Anthony School Building Assessment - Volume I

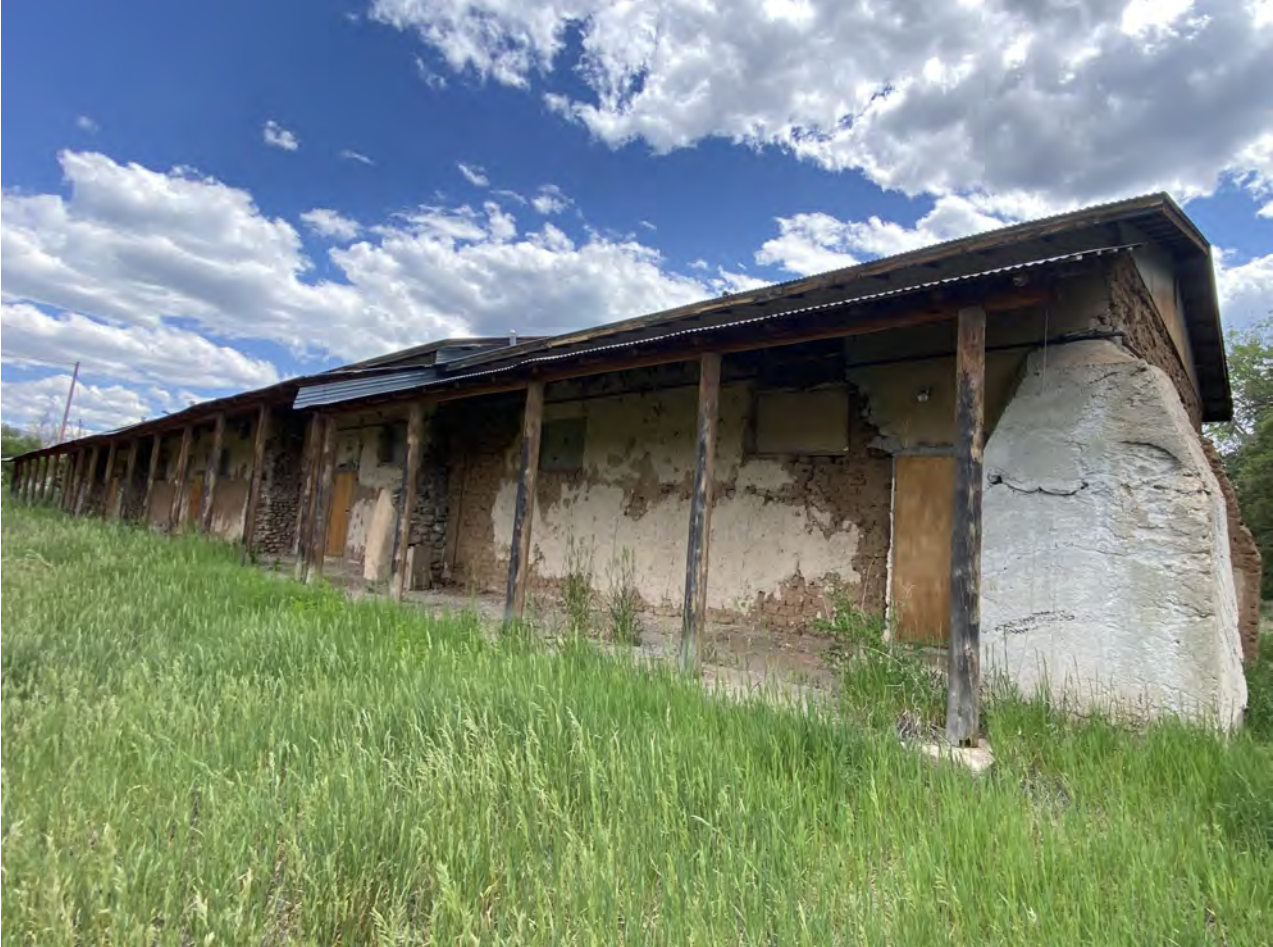
new compatible adobe blocks. Cement based stucco has been removed at some locations and needs to be removed.

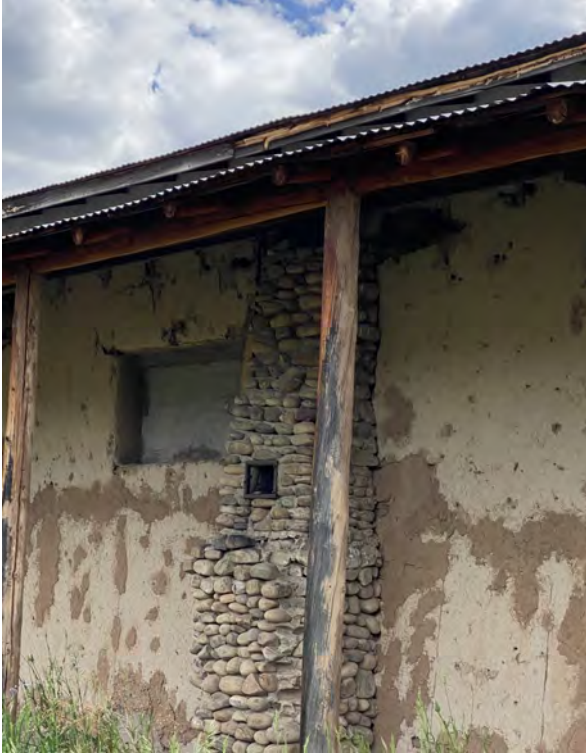
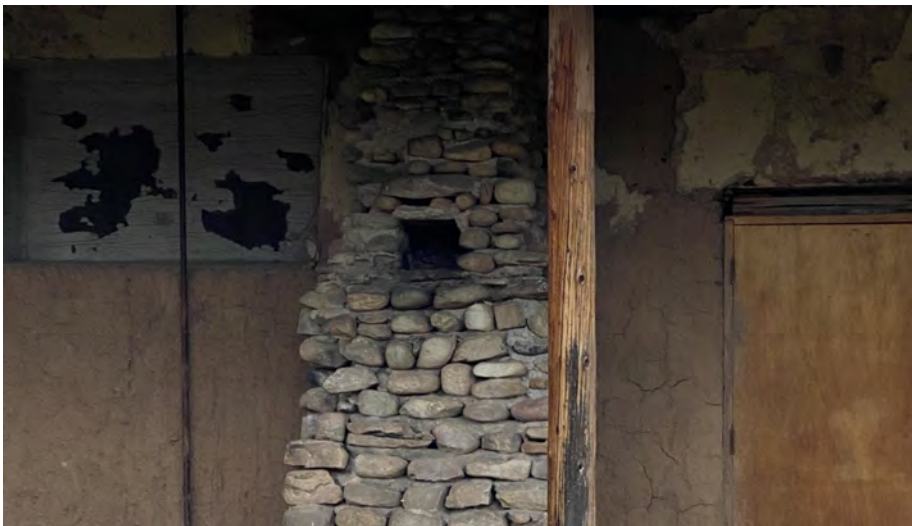
Stonework chimneys need repair or replacement.

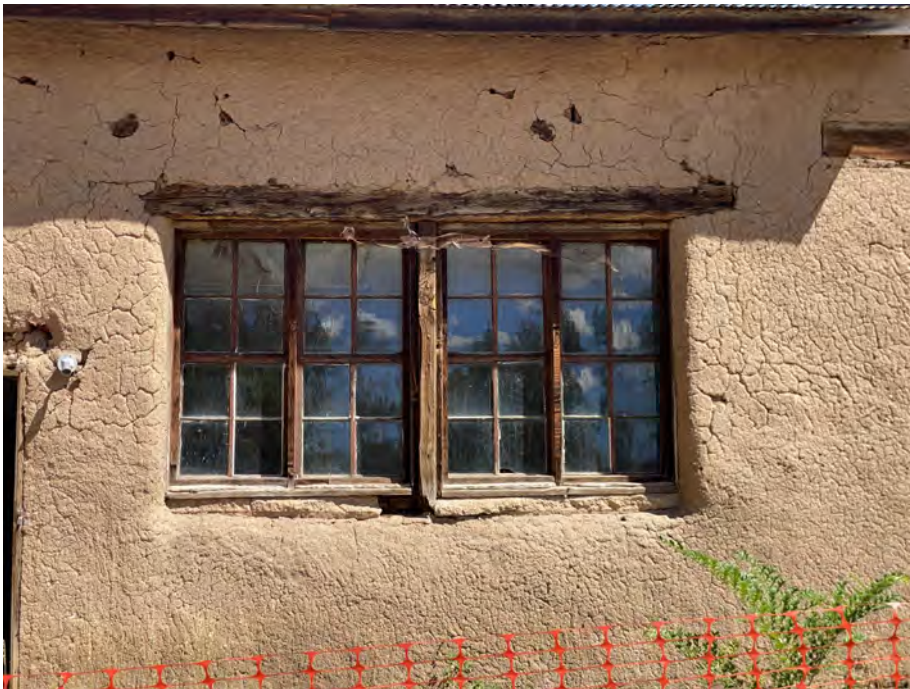
Wood framing at the windows on the front elevation is severely deteriorated.

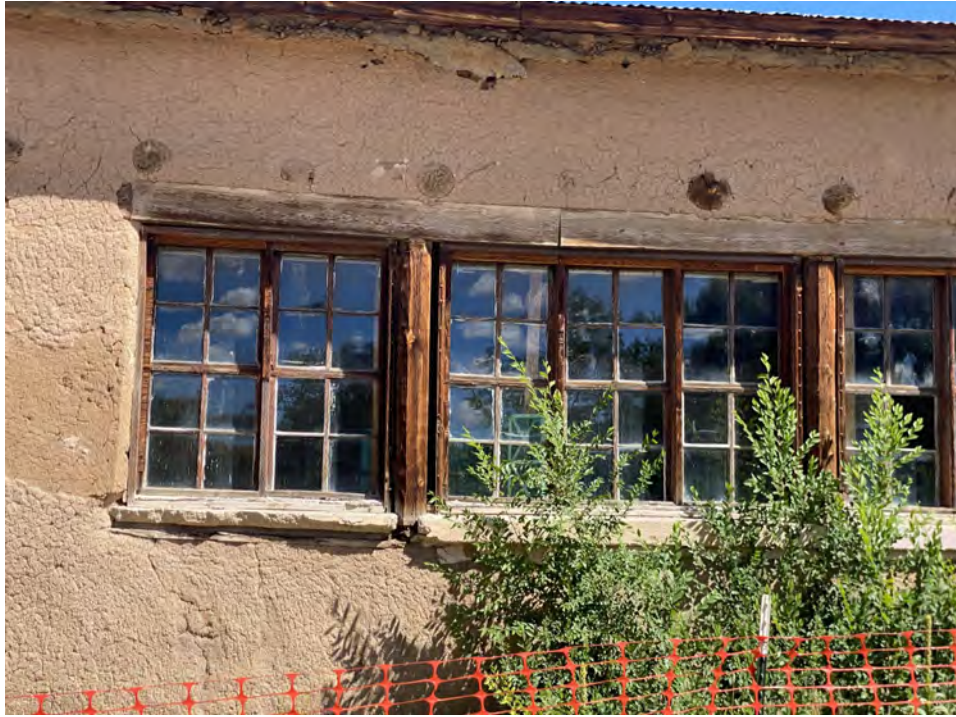
Deteriorating wood framing, wall settlement and incompetent load path contributed to an unstable condition at the front wall.

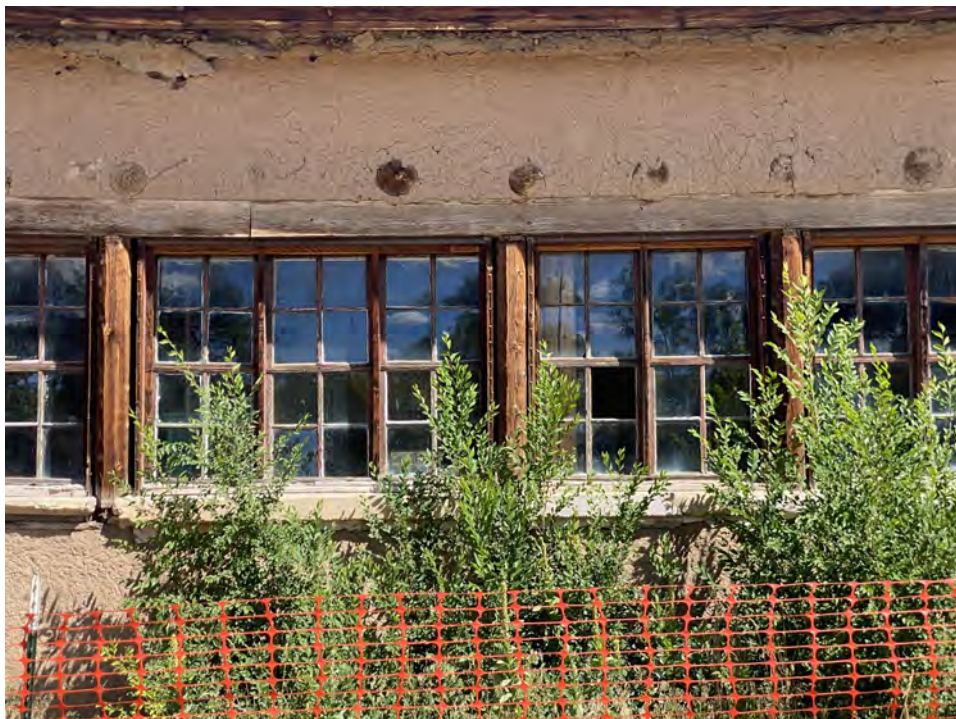
DRUC ENGINEERING, LLC
STRUCTURAL ENGINEERS

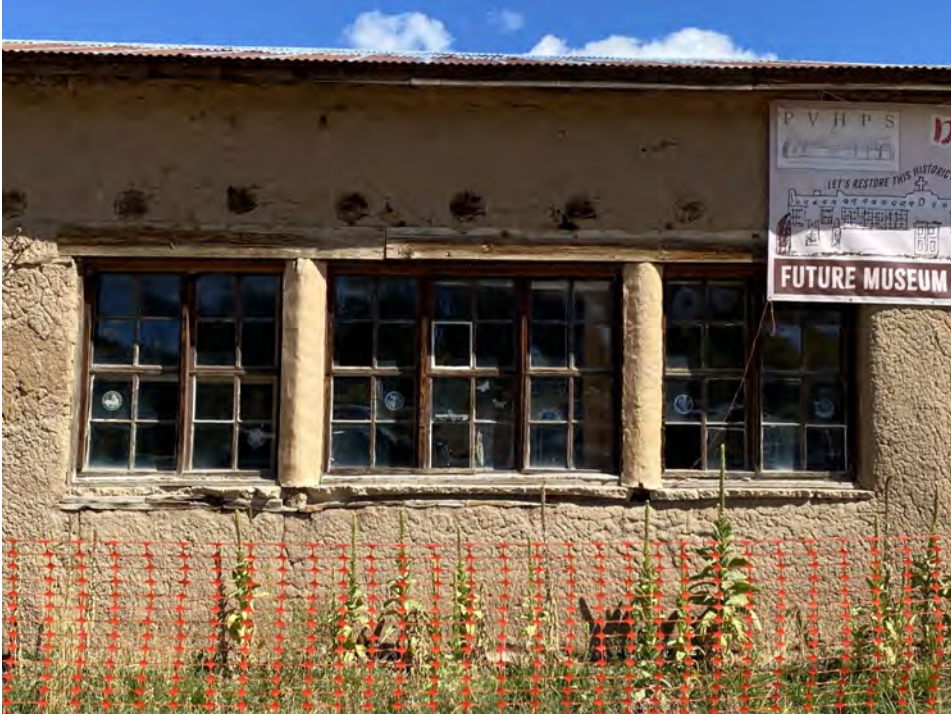
Load bearing wood columns are supported on deteriorating wood blocks and sills at walls affected by settlement. This condition needs to be addressed and repaired.

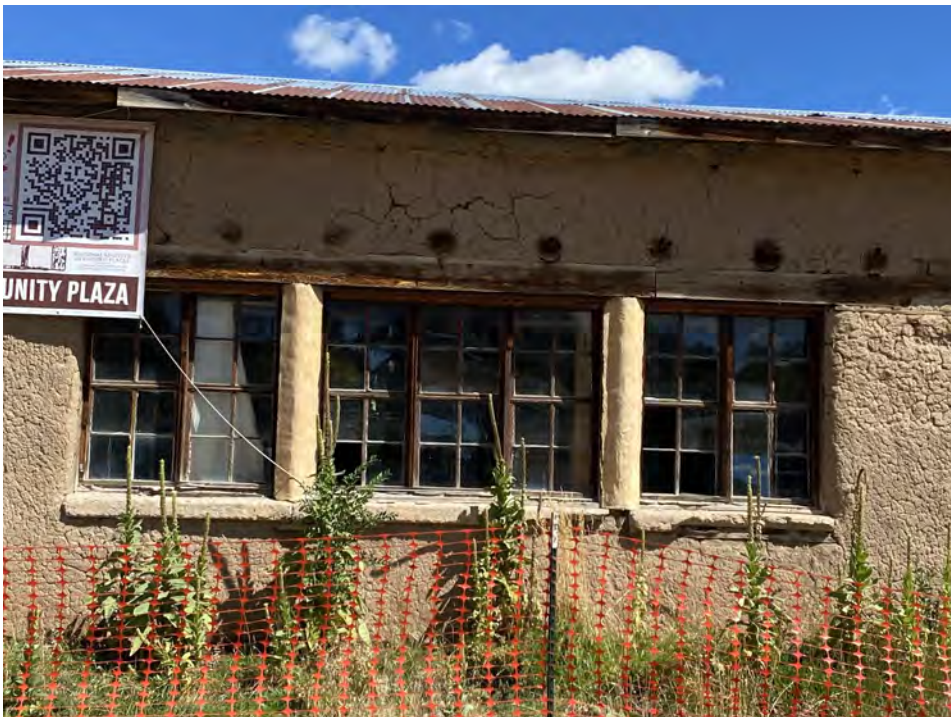
DRUC ENGINEERING, LLC
STRUCTURAL ENGINEERS

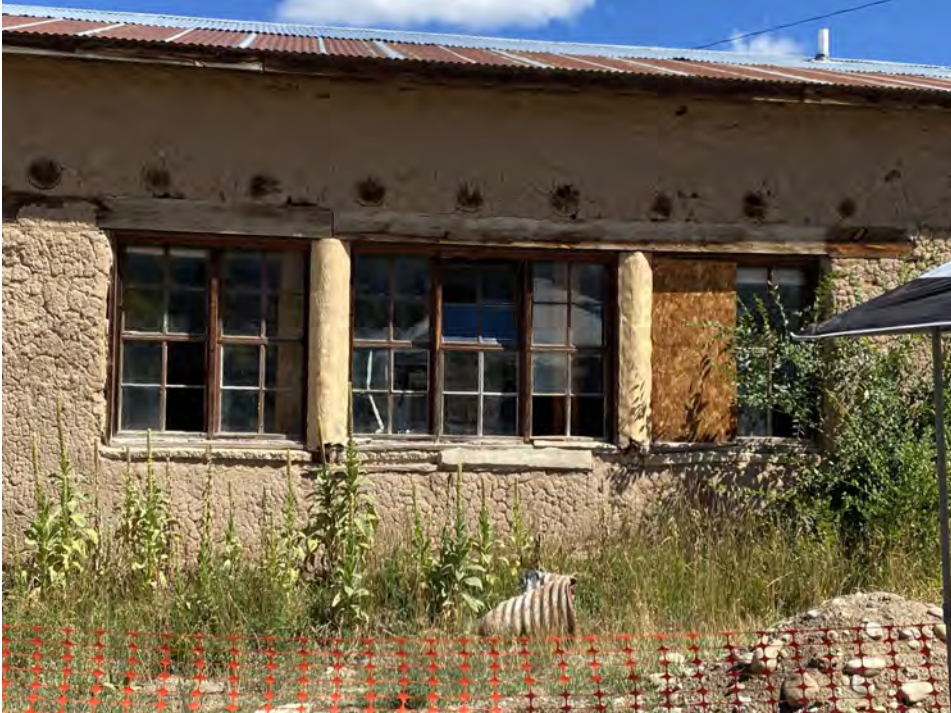
Roof loads are transferred by wood columns between the windows to the adobe wall below. Walls have been subject to moisture and erosion of the adobes at the base of the wall. Point loads on the adobe are unsustainable.

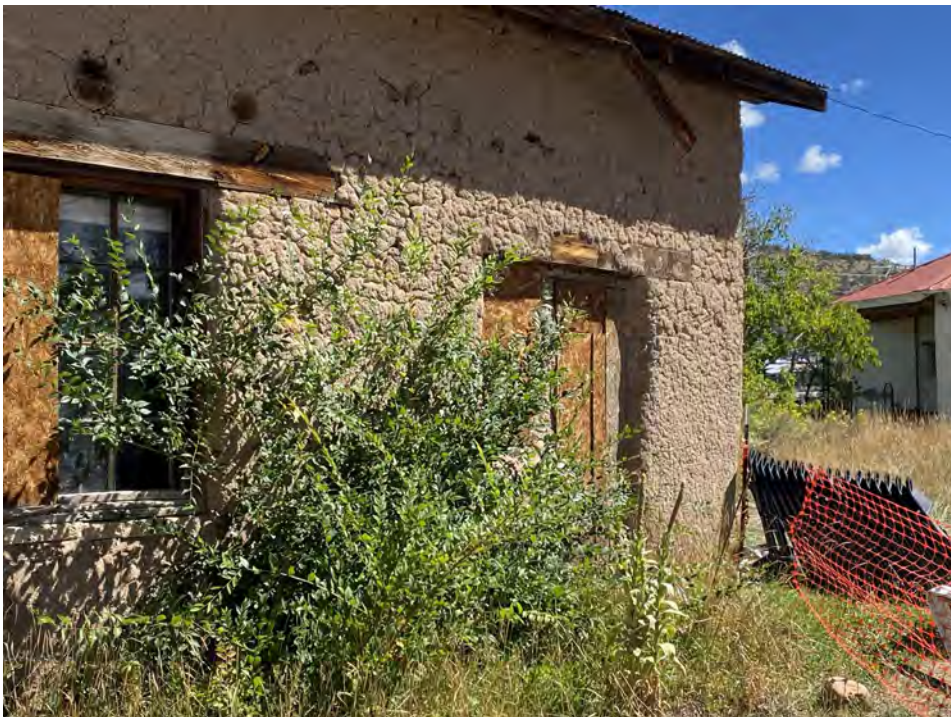
DRUC ENGINEERING, LLC
STRUCTURAL ENGINEERS

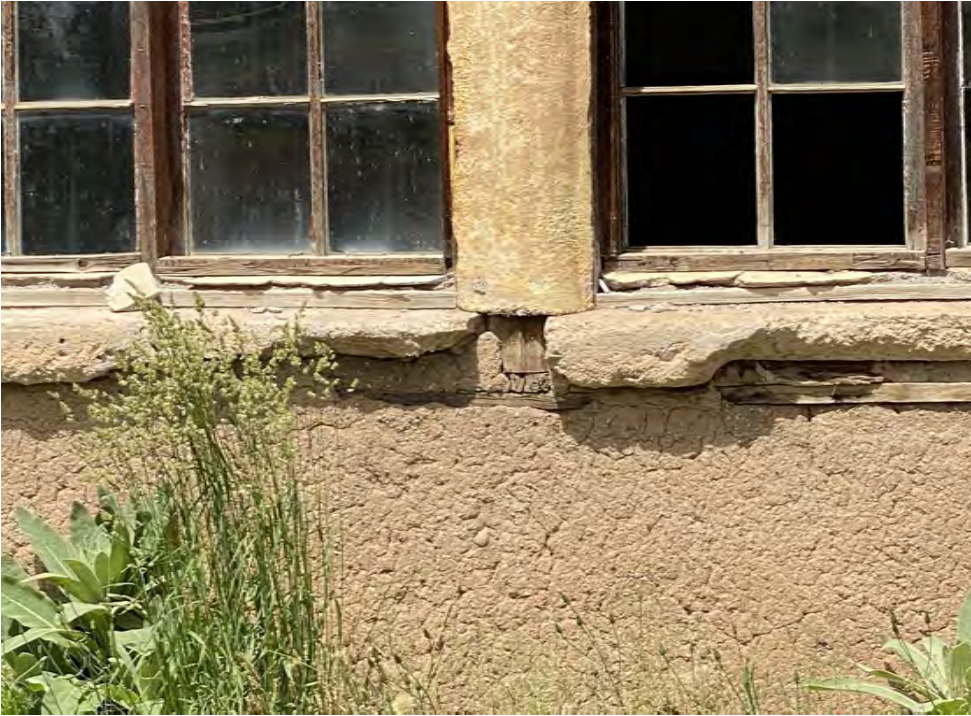
Concrete sills are cracked revealing the wood framing that supports the lintels bearing the wall and roof weight. The point load bears on the adobe wall beneath the window.

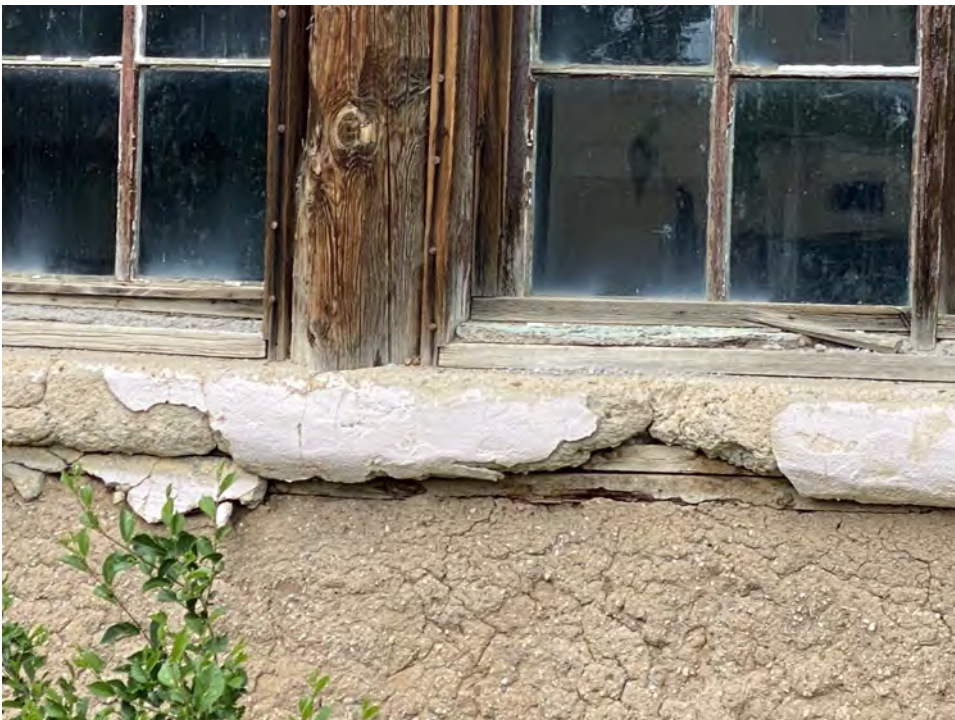
DRUC ENGINEERING, LLC
STRUCTURAL ENGINEERS

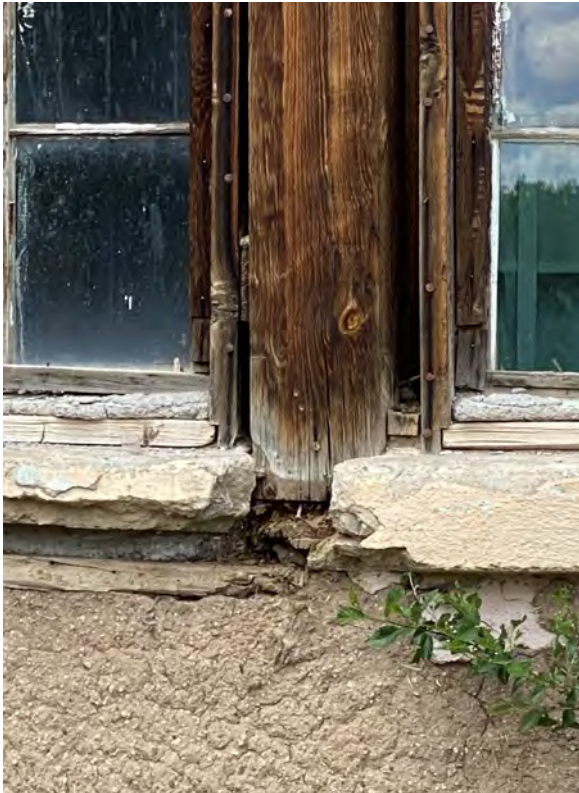
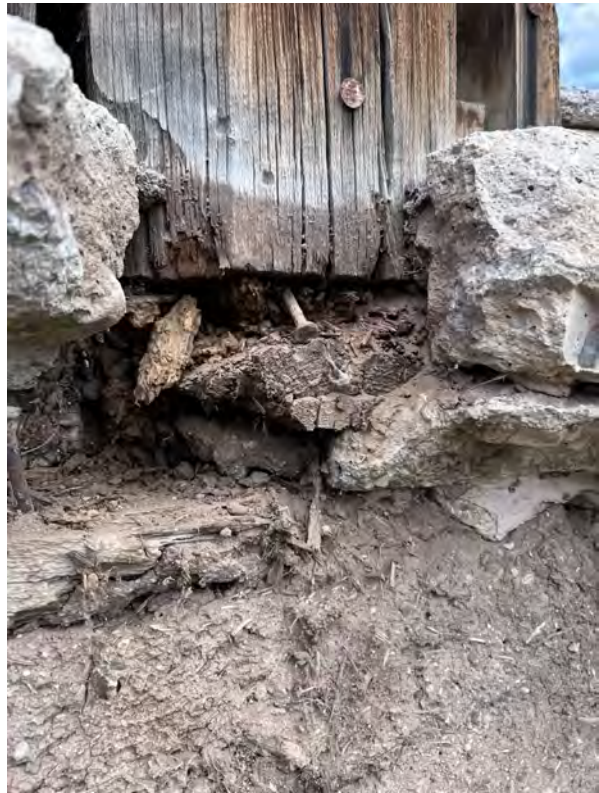
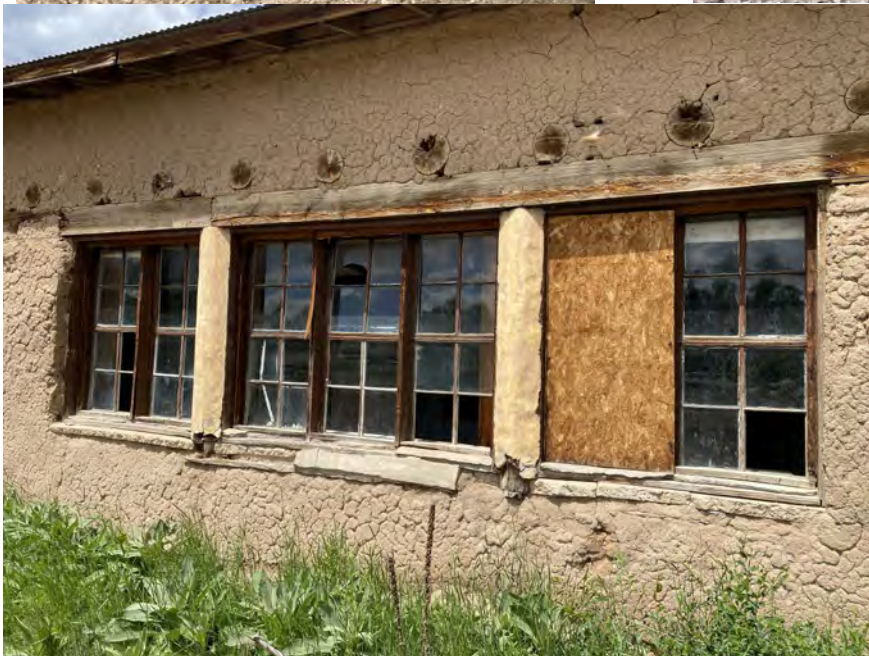
Base of structural wood columns between the windows are deteriorated. Point loads are supported directly onto adobe walls already compromised by base erosion and settlement.

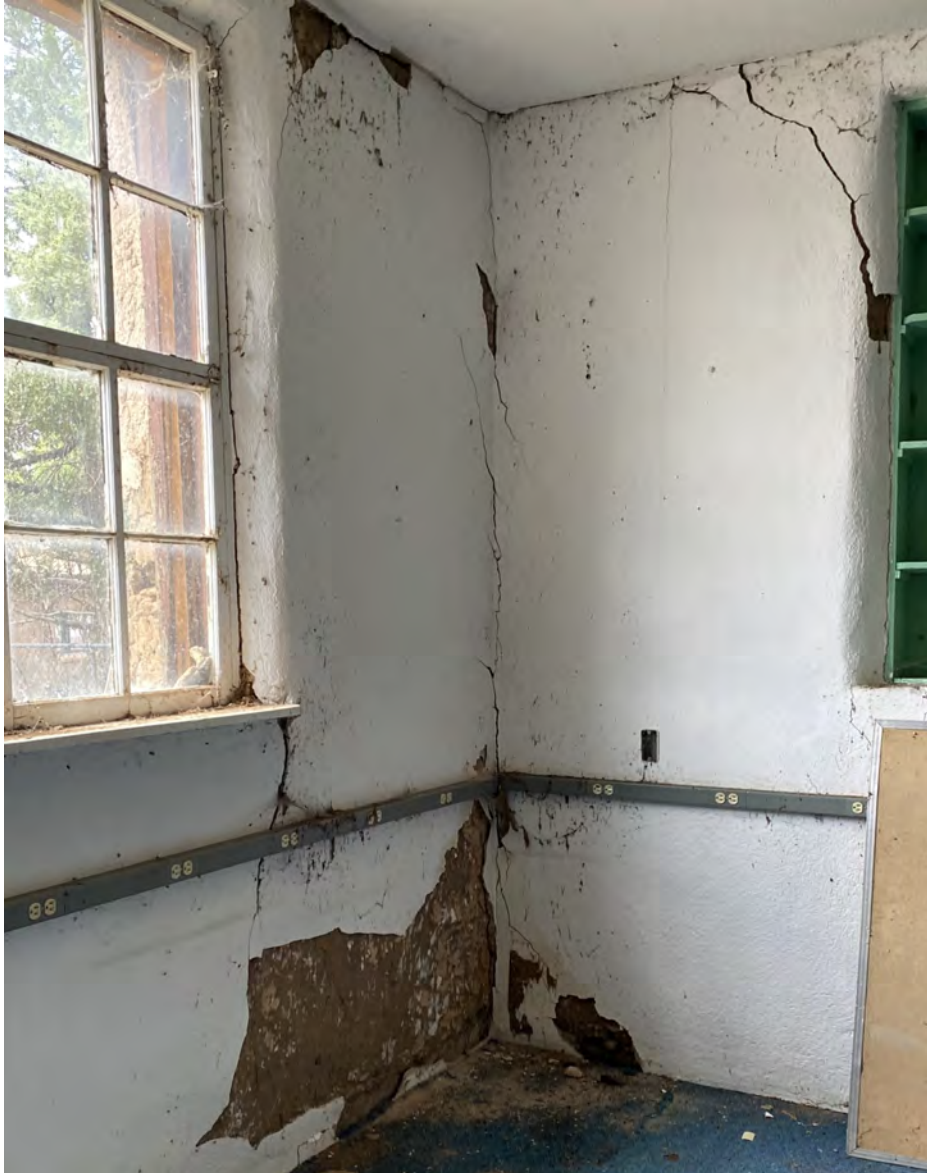
Adobe walls are cracked and plaster is peeling off the wall indicating moisture infiltration and settlement.

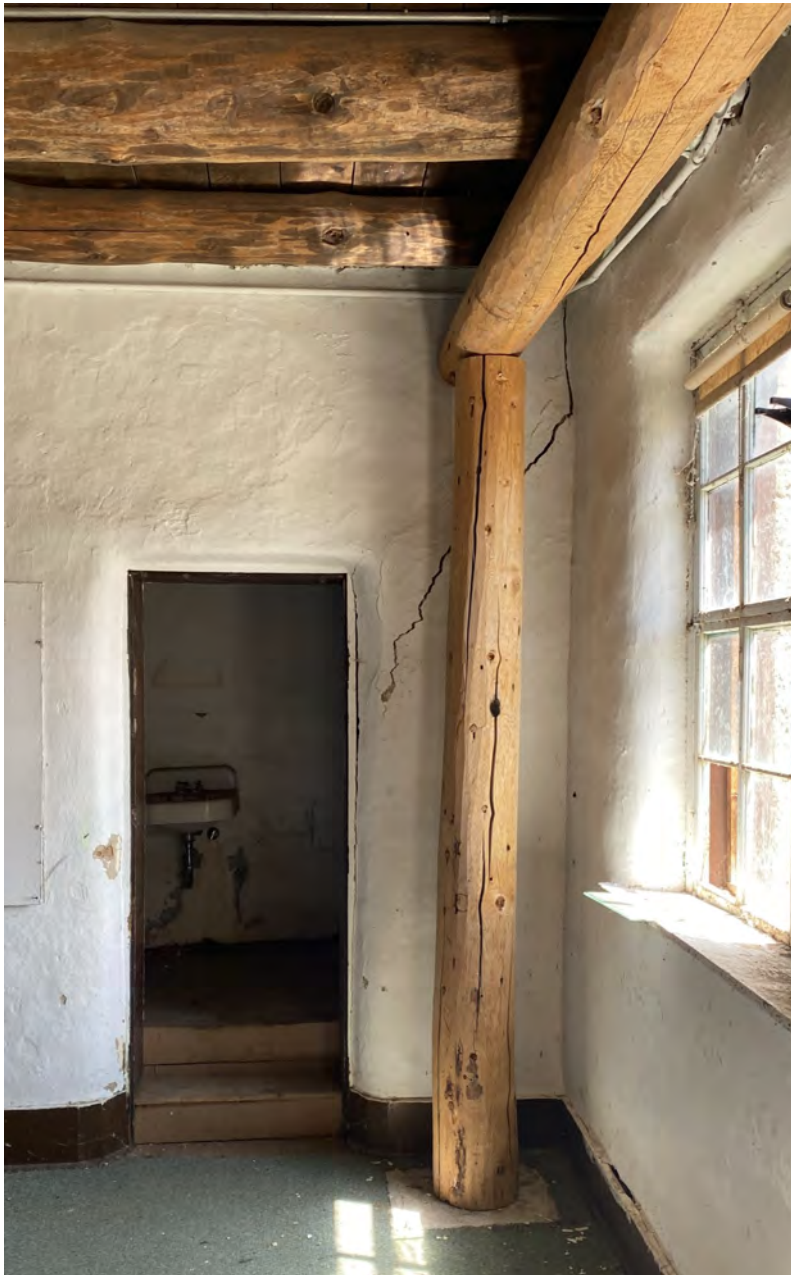
Additional columns and beams framing supported on concrete piers was added to support the roof vigas.

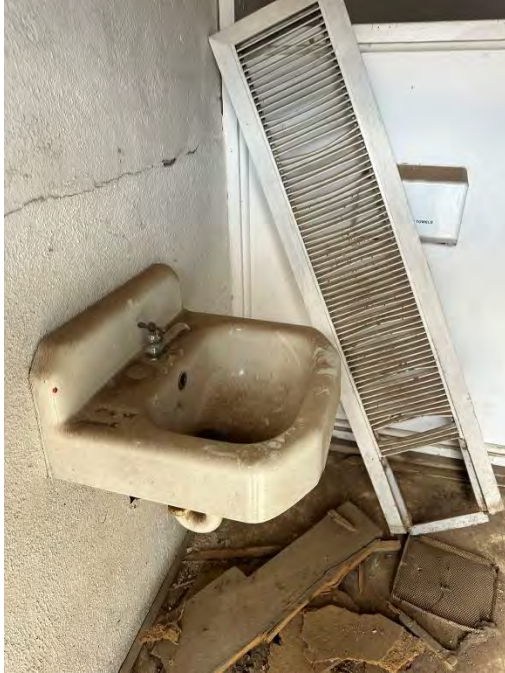
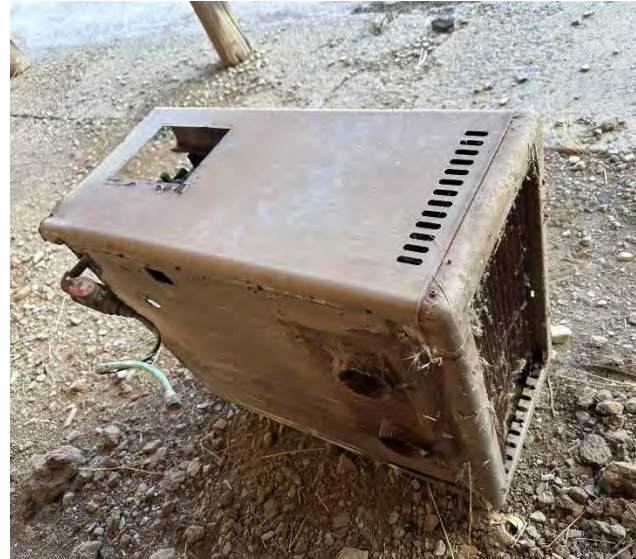
The original plumbing systems has remnants that remain including 2 restrooms (single toilet rooms) and 1 exterior restroom with a trough urinal. Propane was originally piped into the classroom heating units. Most of the heating units have been removed.
